TECHNICAL REPORT ECOM- 2569

AERIAL RECONNAISSANCE IN THE TROPICS (U)

PROJECT ART

15 MARCH 1965

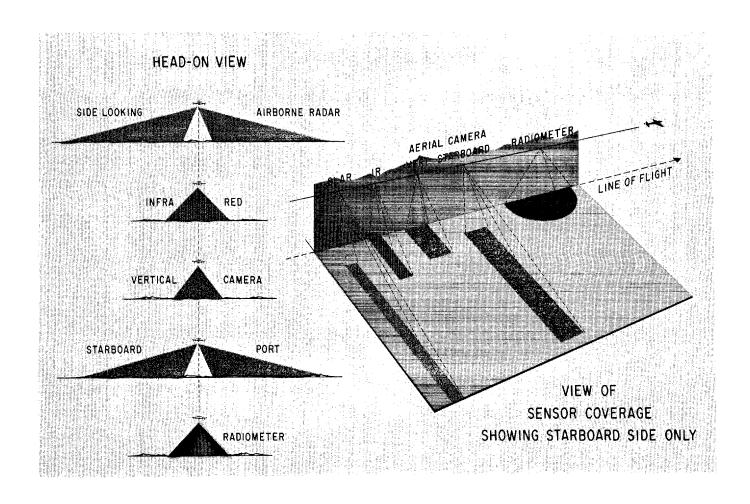
Figure 3. (U) Multisensor Coverage Patterns

The USAEL JC-47J was instrumented with a modified AN/APQ-86 side-looking airborne radar, an AN/UAS-5 infrared system, two KA-50A aerial cameras, and a Barnes radiometer. All sensors were programmed to be operating on each mission, and thus simultaneous ground coverage was provided by the cameras, the IR, and the radiometer. On alternate passes "over" the target arrays, the SLAR provided radar coverage of the ground targets. Figure 3 shows the coverage pattern provided by these four sensors.

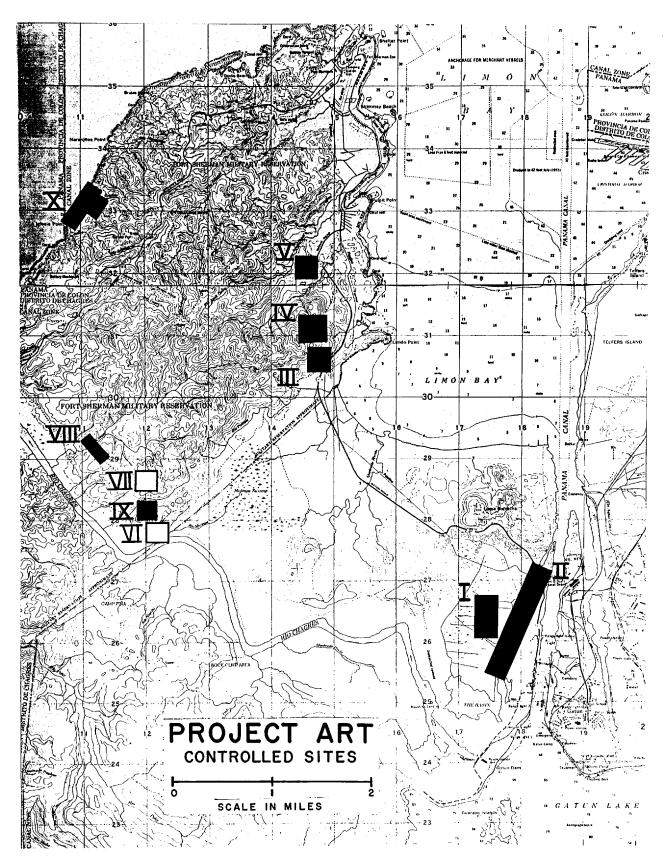
Figure 6. (U) Project ART Site Locations

Figure 6 is a map of the Fort Sherman area showing the locations of the 10 ground sites. The locations of these sites were selected in order to present the greatest possible variety of terrain and jungle growth, the vegetation varying from the short-grass savannah at Site I through tropical rain forests with a variety of canopy heights and densities to the heavy single-story jungle growth of Site III. Table 1 gives a brief description of the canopy cover at each of the eight sites implemented. From the map of Figure 6 one can observe how close together substantially different biotic environments were found. Controlled situations were staged at each of these sites to represent a variety of possible guerrilla operations including mounted patrol, road ambush, bivouac (to include vehicle park), and canal crossing. In each case the positions of personnel, guns, vehicles, trenches, and camouflaged and concealed items were photographed in black and white and sometimes in color, and carefully plotted on sketch maps. Later these positions were plotted on the large-scale aerial KA-39A photographs of the sites taken from the Otter aircraft. During the period that aircraft were obtaining imagery, detailed temperature, relative humidity, and wind velocity data were obtained for appropriate points within each site. Numerous ground photographs were taken at each site to support the subsequent interpretation of aerial imagery.

As can be seen from the map of Figure 6, this site was located along a portion of the French Canal with lush overhanging vegetation and a road paralleling the Canal. At this site there were established three tactical guerrilla situations as shown by the sketch (Figure 9). A seven-vehicle convoy with four motors off and three on, in the configuration shown, was staged along the road. An ambush position consisting of 13 riflemen and two machine guns was set up along the Canal, and three small boats typical of the type currently being used by the Viet Cong in Vietnam were placed in the Canal. Two of the boats, one with an outboard motor and manned by two men and the other a cayuca and manned by three men (see Figure 10), plied the Canal in a manner that might be ascribed to infiltrating guerrillas. The third boat, a cayuca with three men aboard (see Figure 11), remained tied to a large tree and was partially concealed from aerial view by the tree. In addition to these three situations, a six-inch firepot was placed on the road at the south end of the vehicle convoy.

These two sites were planned for the positions indicated on the map of Figure 6. However, because of time pressure, they were never implemented.

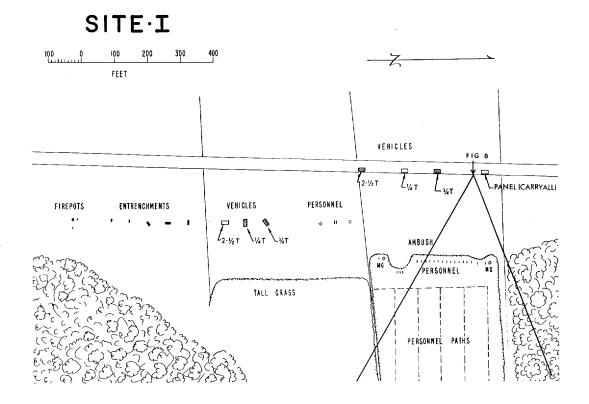
Figure 7. (U) Detailed Sketch of Site I

Figure 7 is a detailed sketch of Site I. Initially, as represented by this site, all vehicles, entrenchments, and firepots as noted here were in the open as were also six personnel. The sizes, separations, and alignments of the firepots and entrenchments and the fact that they were deployed in clear line-of-sight of the overflying aircraft was intended: first, to represent the flat tall-grass savannah situation found in Southeast Asia; second, to provide opportunity for obtaining basic signatures of the target elements to be used in subsequent staging of tactical targets; and third, to allow for resolution studies of the airborne sensors. The two small firepots were six inches in diameter, and the large one was 12 inches in diameter. These charcoal firepots were used here and in subsequent target stagings to represent hibachi-type pots used by Southeast Asians for cooking and warming. The entrenchments from left to right in Figure 7 were the following length, width, and depth respectively:

In addition, the entrenchments were under various degrees of camouflage. (One foxhole was completely camouflaged.) During overflights of this site, the engines of the 2-1/2 ton and the 3/4-ton vehicles on the road and the 3/4-ton and the 1/4-ton vehicles parked off-road in the grass (the hashed rectangles of Figure 7) were

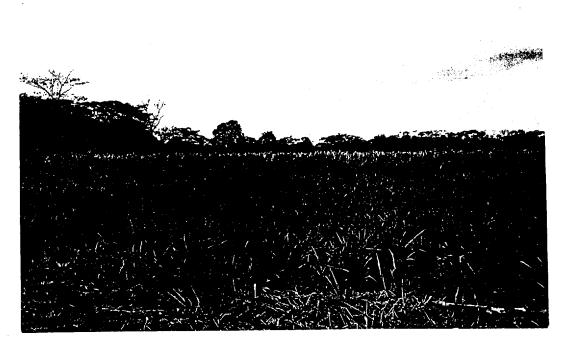
Figure 8. (U) Ground View of Ambush at Site I
Taken from the Road

The personnel lying in the short savannah grassland were lying in groups of two in three different directions, each group separated by about 30 feet, and each person within a group by about 10 feet. In addition to these people in the clearing, there were 18 men lying in ambush in the tall savannah grass and four other men manning two concealed machine guns. Figure 7 shows the configuration of the ambush situation, and Figure 8 shows how this ambush site appeared from the road. The dashed lines of Figure 7 marked "personnel paths" were paths taken by the troops through the six-foot grass to get to the woods (not shown on the sketch). These paths were accurately controlled and recorded to determine whether the paths left by infiltrating guerrillas through such growth could be detected from aerial imagery. The three long lines perpendicular to and on each side of the road are drainage ditches.

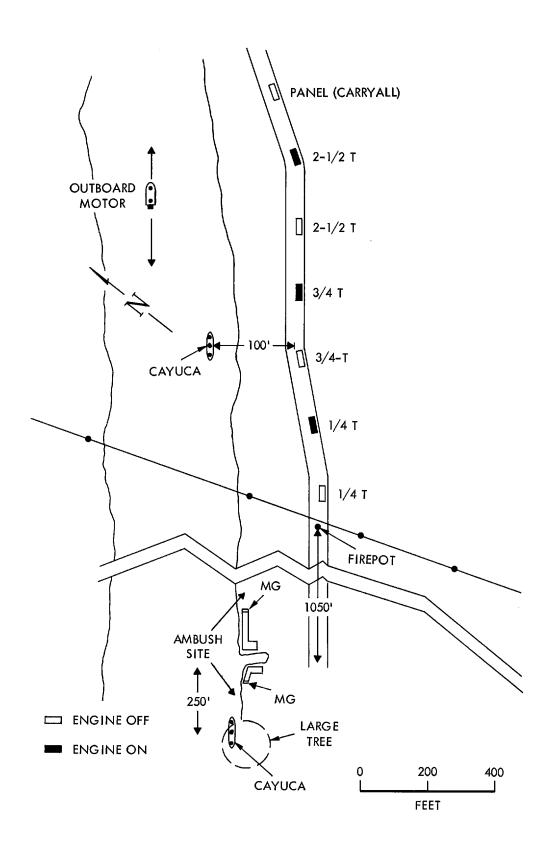
Figure 9. (U) Detailed Sketch of Site II

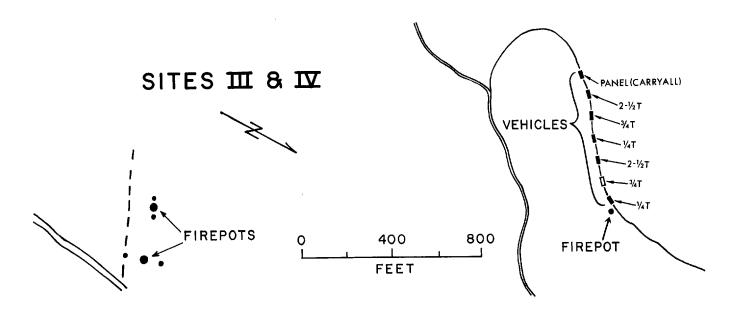
Figure 12. (U) Detailed Sketch of Sites III and IV

Site IV, located slightly north of Site III in multistory, second-growth vegetation and shown as the other part of Figure 12, was intended to simulate a seven-vehicle road patrol. The trail on which the road patrol was located was a narrow, dirt trail intermittently obscured by overhanging vegetation, with the result that the emplaced vehicles were generally masked from vertical observation. Figure 13, a ground photograph showing the lead vehicle of the convoy, is presented here to demonstrate the degree of canopy coverage provided for the first two vehicles.

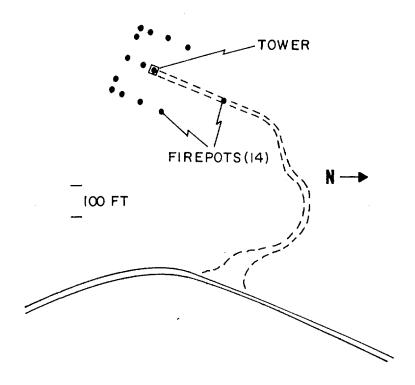
Figure 14. (U) Detailed Sketch of Site V

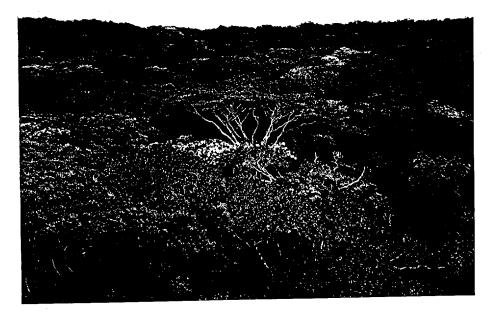
Figure 17. (U) Aerial Oblique of Canopy Cover at Site VIII

The bridge across the Rio Congo River, as seen from the ground in Figure 16 and from the air by way of a high oblique in Figure 17, was the location of Site VIII. This site was intended to simulate the preparation of a road ambush situation with weapon and guerrilla-carrying vehicles still in the area. Vegetation in the area was of the multistory, second-growth type typical of tropical areas. This vegetation canopied over the trail in such a way that the trail was only intermittently visible from overhead. Figure 18 is a sketch of this site, showing the orientation and position of each of the seven vehicles. A six-inch firepot was placed at the northwestern edge of the site for reference purposes. The vehicle types, parked on the trail and with engines off, were the same as those used for Sites I, II, and IV, spaced 75 feet apart.

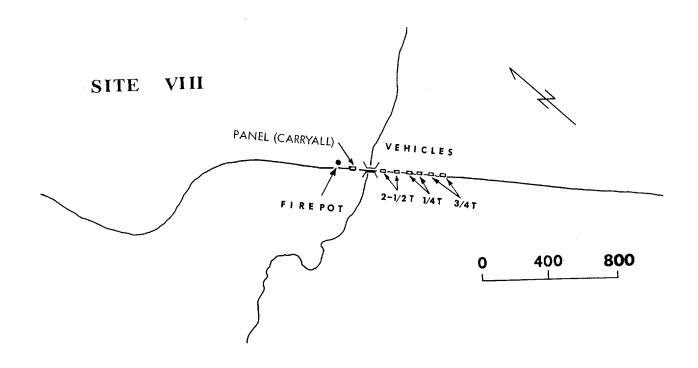
Figure 18. (U) Detailed Sketch of Site VIII

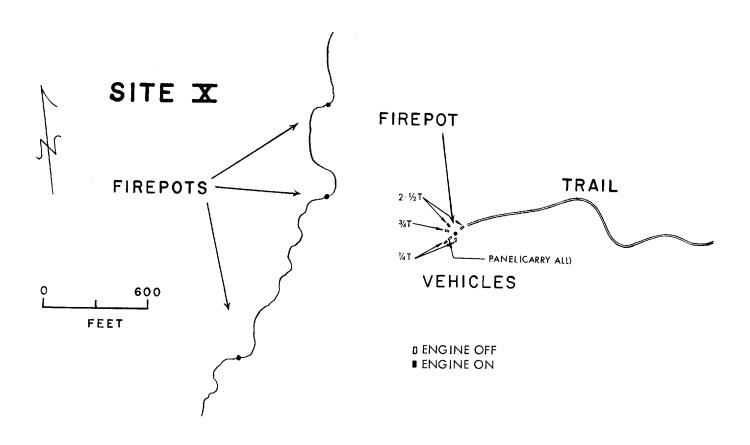
Figure 24. (U) Detailed Sketch of Site X (description on p. 25)

At Site X along the sea coast, the geographical location of which is shown on the map of Figure 6 and an aerial view of which is shown in Figure 22, a series of natural sea caves was utilized. Firepots were placed in three of the caves along the shore. Figure 23, a ground photograph of one of these caves, shows one of the firepots. Beyond the caves in a small clearing was staged a bivouac of a mounted unit. Six vehicles were emplaced on the perimeter of a small clearing at the end of a trail in multistory second-growth vegetation. (A seventh vehicle, a 3/4-ton truck, was parked behind the panel truck on 20 April 1964 between 1900 and 2100 hours.) A firepot was placed in the center of the clearing as an infrared reference source. Figure 24 shows the layout of Site X. During the infrared missions, only two of the vehicles were engines-on - the 2-1/2 ton truck on the northwest perimeter and the 1/4-ton truck more distant from the firepot.

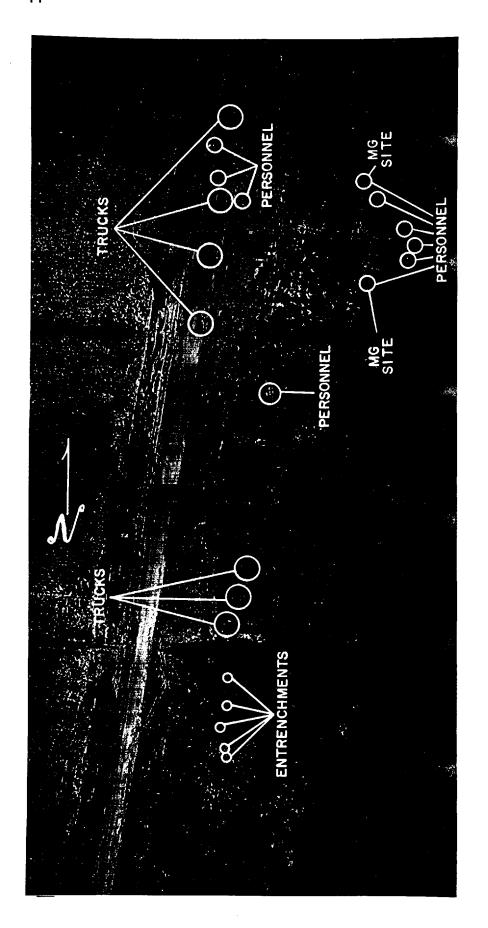
Figure 28. (U) Site I - KA-50A, Color Infrared

Figure 28, a color infrared (Camouflage Detection) mosaic of this site, depicts the vegetation in one or another shade of red. In this figure, the vehicles are once again very readily detectable; now, however, more so (however negligible) against the grass than against the lighter background of the road. The white-shirted personnel are also perhaps even a little more detectable here than in Figure 27 as are the six men lying in the short grass. The machine gun positions of the ambush are here evidenced by the distinct gray spots caused by the trampling and killing of the vegetation in these areas. (Note the trampled, dead grass in this area shown in Figure 29). On very careful examination of the originals one can also now note the positions of the personnel, although the personnel themselves are not detectable in this situation. The diggings did not reveal themselves on this film as was initially expected, and the following possible explanation is made. The ''dead'' foliage which was used to camouflage the entrenchments and was expected to be the primary clue in revealing their presence was relatively fresh and still very infrared active. As a matter of fact, the camouflage itself is the clue that might be used in detecting these diggings in the color shot of Figure 27. Here, in the apparent haste to set up the camouflage, the bright green undersides

of the leaves of the foliage were left exposed to aerial view and contrasted well with the other adjacent untampered-with vegetation. In Figure 28, in the last truck (a 2-1/2 ton) in line along the road, one can notice a little red blob in place of the brown blob of Figure 27. This bright red spot is obviously freshly cut vegetation. Figure 30 is a black and white mosaic of the same site without the minus blue filter and compares favorably with the view of Figure 25. Figure 31 is an Anscochrome view of this site taken under rather poor light conditions. Figure 32 is the AN/APQ-86 Side-Looking Airborne Radar view of the same scene, but includes a much larger area. Site I in this figure is generally confined to the area enclosed within the small rectangle where the vehicle radar returns show up clearly against the non-reflective road. The jungle vegetation is intangible as far as interest in counterinsurgency-type targets is concerned and as far as the vehicles themselves are concerned along any trail that is not open. This SLAR record typifies what is to be expected over this type of terrain with this type of radar. Figures 33 and 41, which cover the micron region from 1.0 to 5.5 and 8 to 13.5, yield a comparison of daytime infrared with conventional photography and SLAR over Site I. The second of these two figures, covering the micron region from 1.0 to 5.5, provides an excellent detection of all vehicles appearing as cold targets and of three distinct, easily resolvable firepots which appear as hot targets. The four partially camouflaged entrenchments are also relatively easily detectable. On Figure 33, which covers the 8.5 to 13.5 micron region, all vehicles are detectable, as are the three firepots; however, the entrenchments are not detectable. All detectable targets appear here hotter than their surroundings. (This phenomenon of hot and cold targets depends to a large extent on the background and on the spectral region used.)

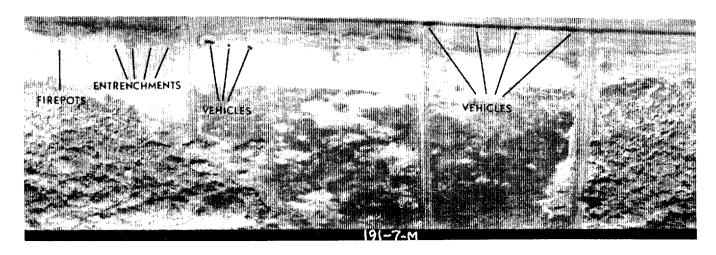
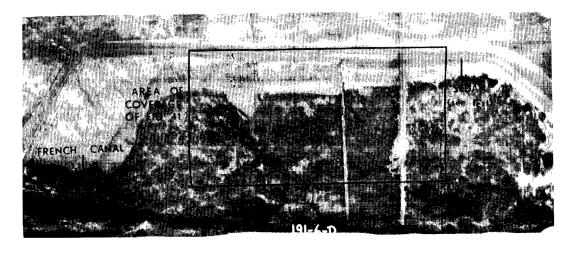
Figure 41. (C) Site I - M-2 Scanner, $1.0-5.5\mu$, Altitude 500 Feet, 141140 April 64

Figure 42. (C) Site I - M-2 Scanner, 2.0-2.6 μ , Altitude 500 Feet, 141137 April 64

Figure 43. (C) Site I - D-2 Scanner, $8.5-13.5\mu$, Altitude 500 Feet, 141137 April 64

correctly represent the thermal conditions of Site I. Although the entrenchments are no longer apparent, all vehicles come through as warmer than background. Figures 41 through 43 show a similar wavelength effect at a flight altitude of 500 feet. Comparison of Figures 37 through 43 shows that little difference other than image size exists between the two altitude samples. The relative contrasts of the several target components at a given wavelength are relatively constant across the two altitude samples.

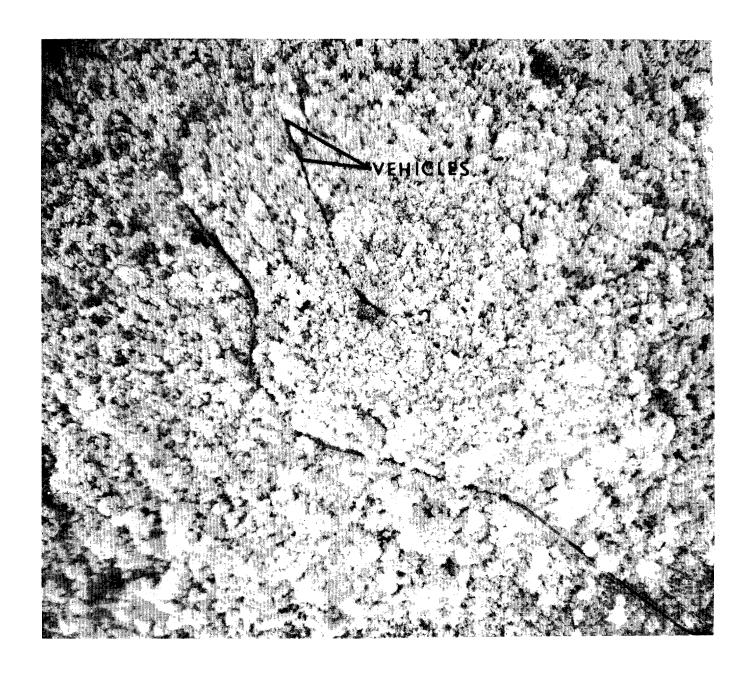
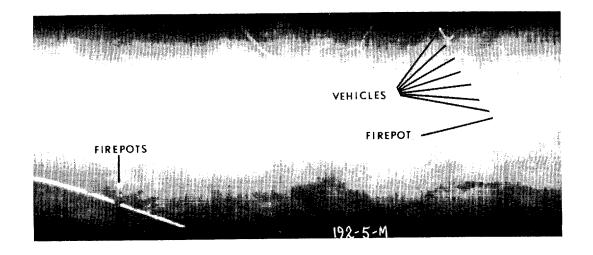
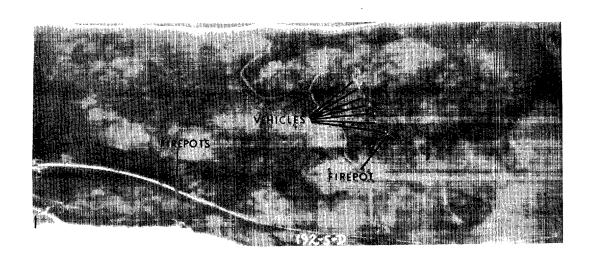
Figure 47. (U) Site IV - KA-50A, Black and White Infrared

Figure 48. (C) Sites III and IV - M-2 Scanner, 1.0-5.5 μ , Altitude 1000 Feet, 150417 April 64

Figure 49. (C) Sites III and IV - D-2 Scanner, $8.5-13.5\mu$, Altitude 1000 Feet, 150417 April 64

Figures 46 through 49 depict the comparative sensor cover of Sites III and IV. In Figure 46, which is a camouflage detection view of Site IV, it can be noted that the lead vehicle (the one closest to the firepot) stands out in substantially better relief from the surrounding vegetation than in Figure 47, a black and white infrared view of the same scene. This permits one to better detect the vehicle's presence as well as to identify its type. Figures 48 and 49 represent typical results obtained over these sites at night with infrared over the range from 1.0 to 5.5μ and 8.5 to 13.5μ respectively.

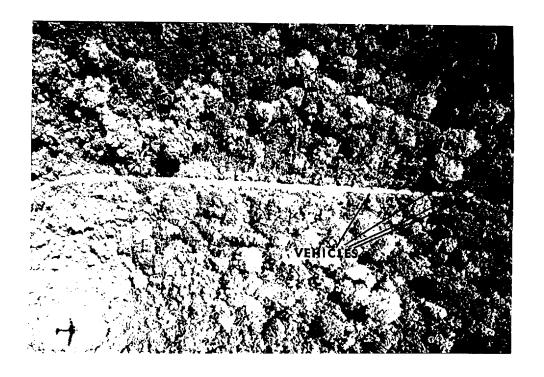
Figure 66. (U) Site VIII - KA-50A, Color (Ektachrome), WR 1A

Figure 66 is a color photograph of the same site. The color photograph here has suffered the greater resolution degradation, but the original color photography reveals the presence of three vehicles and evidence of a fourth, and its black and white counterpart reveals the distinct presence of only three vehicles. (These three vehicles were either in the clear or only partially concealed.) Once again as was noted previously, the color photography offers only a minimal improvement over the conventional Plus-X.

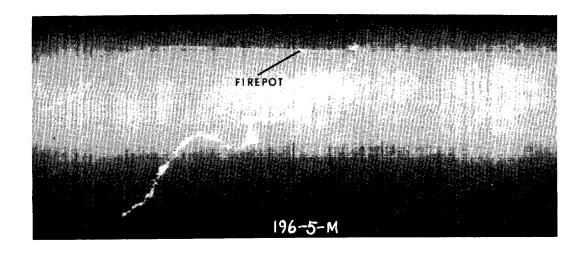
Figure 67. (C) Site VIII - M-2 Scanner, $1.0-5.5\mu$, Altitude 1000 Feet, 170423 April 64

With the predawn mission, the firepot at Site VIII was detected on both successful passes with the short-wavelength M-2 scanner. While close inspection of the imagery negatives suggests a few of the vehicles apparent as cold objects on the trail, the signatures are not adequate to be labelled "detections." Figure 67 shows these equivocal results.

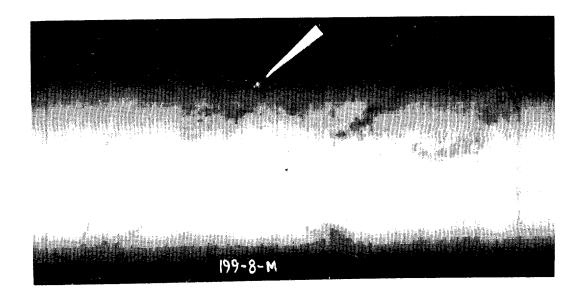
Figure 70. (C) Site X - M-1 Scanner, 1.0-5.5 μ , Altitude 1000 Feet, 200420 April 64

The predawn mission was flown at 1000 feet under wet, overcast conditions. The M-1 scanner was equipped with an unfiltered InSb $(1.0 - 5.5\mu)$ detector for this mission. On the three successful passes of this mission, the firepot was detected each time. Vehicles were detected on only one pass. The vehicles detected were the two engine-on vehicles and the engine-off 3/4-ton truck due south of the firepot. Figure 70 shows these detections.

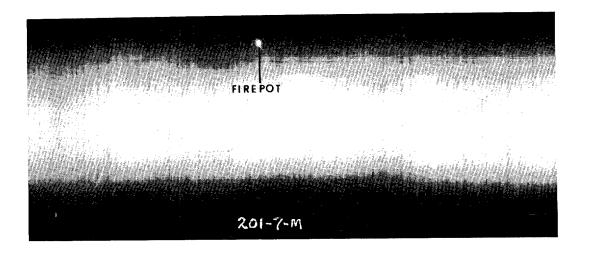
Figure 75. (C) Site X - M-1 Scanner, 1.0-5.5 μ , Altitude 1000 Feet, 202029 April 64

The four successful passes of the evening mission were flown under hazy, scattered-clouds conditions. At 1000 feet with the M-1 scanner operating at 1.0 - 5.5 μ , three of the passes produced firepot detection, and two of these passes included a detectable signature of the engine-on 2-1/2 ton truck. The imagery in Figure 75 is representative of this mission.

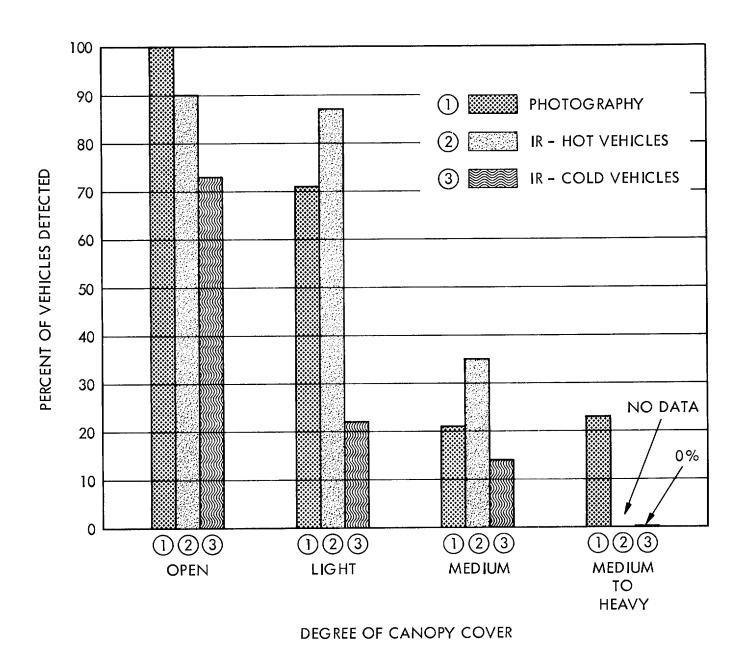
Figure 76. (C) Percentage of Vehicles Detected as a Function of Degree of Canopy Cover

Detection of these targets drops rapidly when moved under canopy, and both systems register very low once even medium-canopy-cover conditions are encountered.
